# TURBINE OVERHAUL FREQUENCY— TIME OR PERFORMANCE BASED?

## ABSTRACT

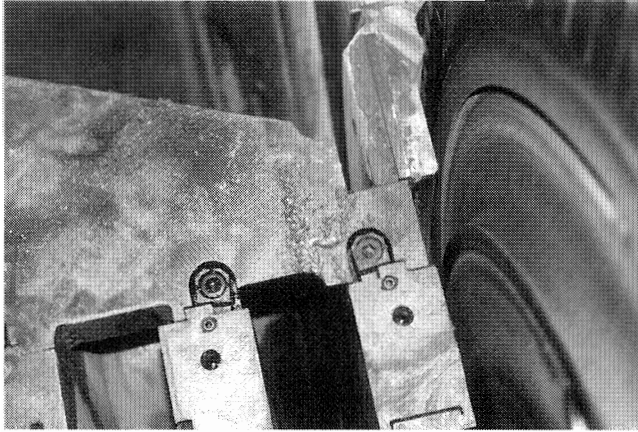
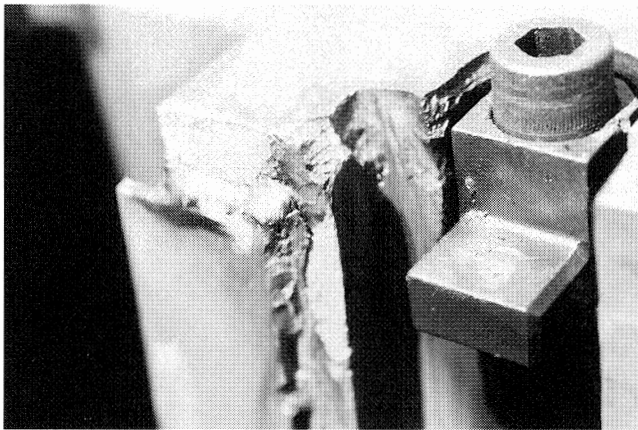
Initial observation revealed no real surprises. Stages 11 through the back end of the turbines showed erosion across the diaphragm splitlines and erosion across some sections of the outer casing splitline (Figures 1 and 2). Some areas were near 0.250 in deep and 0.5 in wide. All seals were intact with no signs of severe rubbing. Seal clearances were close to design, but all labys were brittle. Therefore, all seals were replaced.

Figure 1. Casing Splitline Damage.

Figure 2. Casing Splitline Damage.

Inspection of the high pressure casing revealed no damage. Steam erosion was, however, present in the low pressure casing at the 11 through 14B stages. The erosion damage was confined to the casing splitline near the diaphragm pockets and to the sealing faces of the diaphragm grooves on those stages. As noted earlier, damage in some spots was quite deep, especially near the inside of the splitline.

It is likely that thermal stresses caused the interior of the casing to open slightly. During thermal transients, such as startup and

shutdown, the casing ID heats at a faster rate than the OD. This thermal gradient tries to make the ID expand however it is constrained by the OD. If the gradient is large enough, the ID is forced to yield slightly. Once the thermal gradient is reduced, and thermal stresses are normalized, the splitline inside the bolt pattern can open slightly. Normal casing material is no match for this leakage path combined with wet steam.

- Grind out the eroded areas to suitably prepare them for welding (Figures 16 and 17). Peen the perimeter of weld to raise metal, preventing a visible fusion line.
- Weld repair these areas using a tungsten inert gas (TIG) process and Inconel filler material. Some areas in the low pressure section were repaired using 7018 rods (Figure 18).
- Hand work the repair areas to reestablish a flat splitline. A finished area is shown in Figure 19.

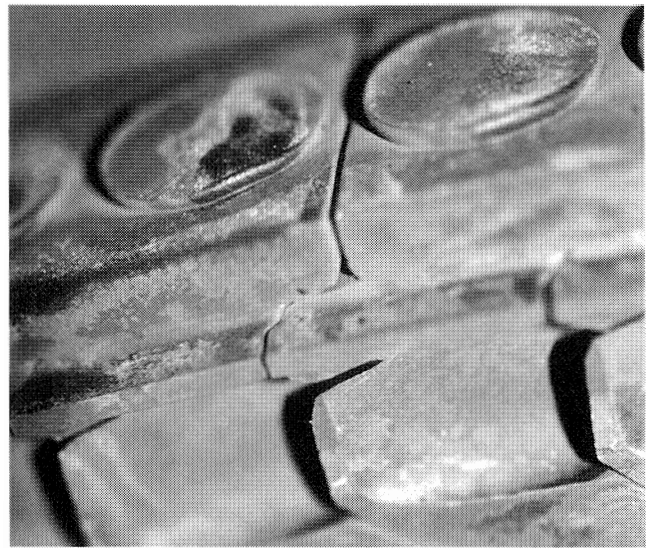
Upon closer visual inspection and the arrival of daylight, damage to the trailing edge of the first stage blades was observed. Each blade had a notch, almost like a saw cut, 1/8 in below the shroud, 3/8 in long, and 1/32 in wide (Figure 3). One turbine, the 60,000 hp unit, showed erosion on the leading edge of the last row of blades, 14B (Figure 4). The erosion was confined to the upper one-third of the blade with 1/16 in of metal removal from the edge. This was not a concern until one blade was found in the same row missing a tenion (Figures 5 and 6). The remainder of the rotor was relatively clean, with no build up of deposits.

Figure 3. First Stage Buckets-Trailing Edge.

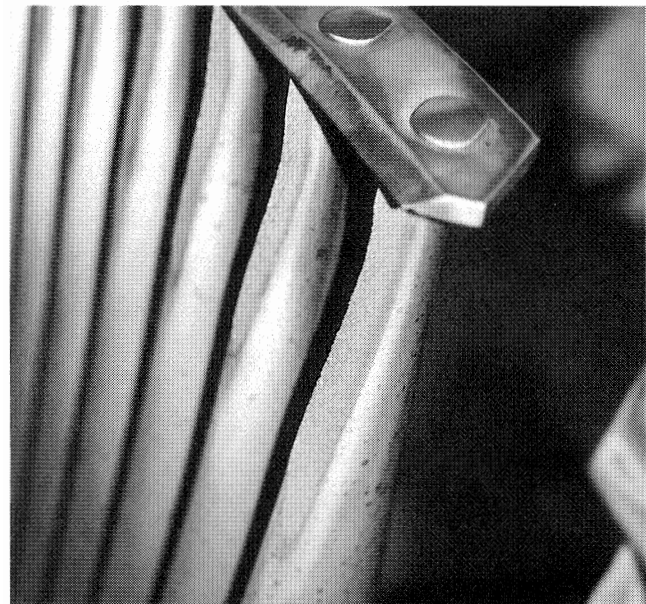
Figure 4. Stage 14B Erosion Damage.

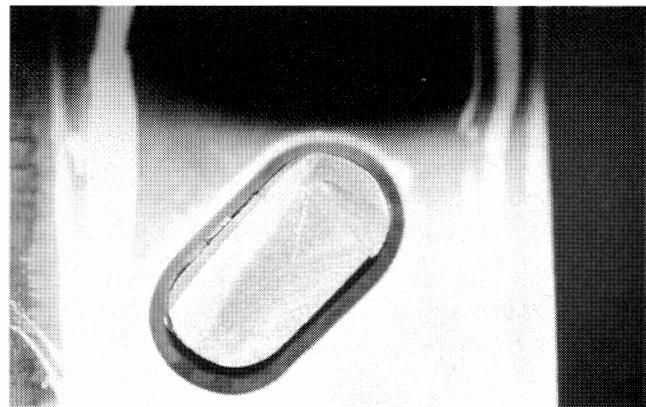
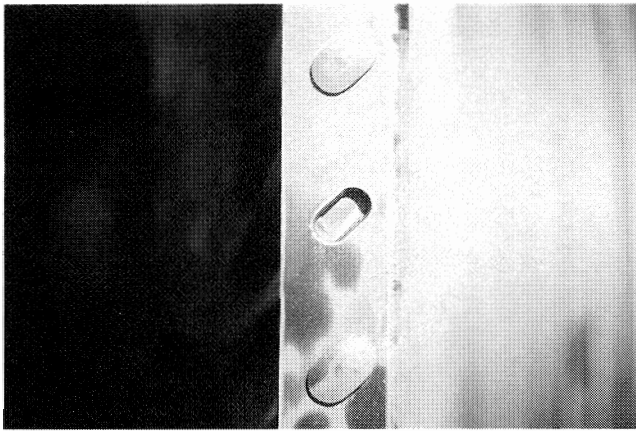
Figure 5. Failed Tenion on Stage 14B.

Figure 6. Failed Tenion on Stage 14B.

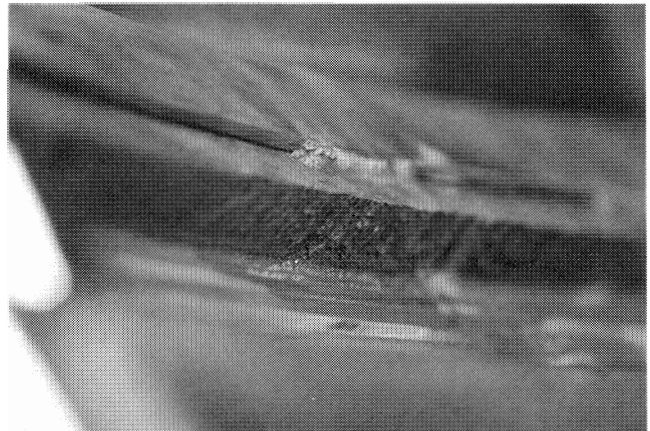
Figure 8. Diaphragm Pocket Sealing Surface Damage.

After rotor and diaphragm removal, significant damage was found. The casing grooves from 11 through 14B had heavy wash out on the sealing surface. Erosion was typically 1/8 to 1/16 in deep and evident 360 degrees around the groove (Figure 8). The diaphragm sealing surface had a matching pattern (Figures 9 and 10). The 360 degree nozzle box had numerous partitions where the trailing edges had broken off. Evidence of these pieces impacting the blades could be found on the first four rows of blades. The bottom center of the nozzle ring had two partitions completely missing (Figure 11).

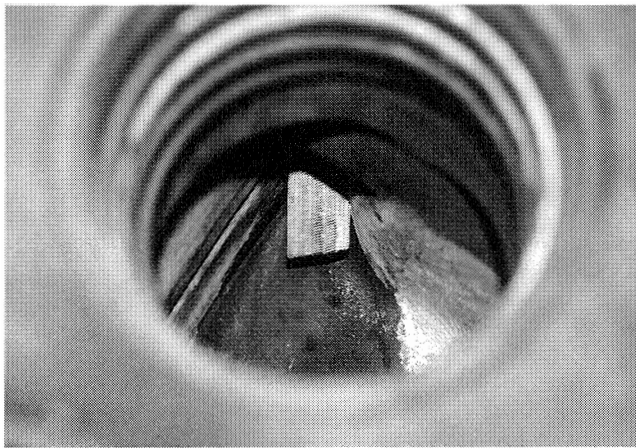
Inspection of the nozzle box inlet and valve ports revealed a little lagniappe. A 12 in file, broken into four pieces, was found in various sections of the nozzle box (Figure 7). Fortunately, the file caused no damage to any part of the machine. Apparently, a

Figure 7. File Found in Inlet Nozzle Port.

craftsmen had used a file as a gasket scraper during a previous maintenance of either the valve rack or trip valve. It appears the file was broken by a governor valve closing down on it.

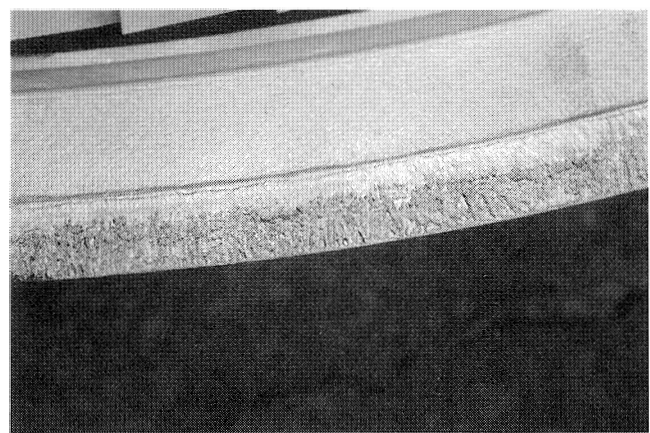
Figure 9. Diaphragm Sealing Surface Damage.

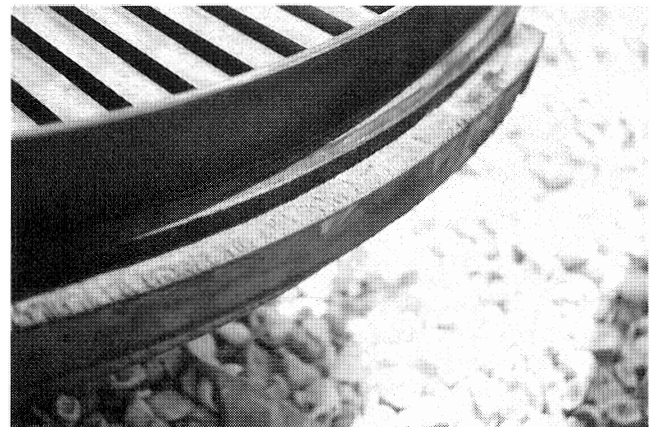
Figure 10. Diaphragm Sealing Surface Damage.

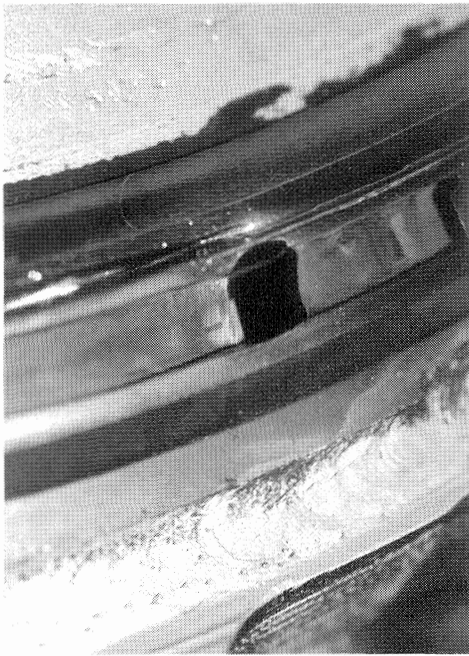
Figure 11. Inlet Nozzle Ring Damage.

The trailing edge of nozzle partitions is very thin. Foreign particles and fatigue combine to cause some of these trailing edges to break off. Approximately one-third of all of the partitions had pieces missing. In addition, the two nozzles at bottom dead center were missing completely with the appearance of being blown out. Damage to the bottom two nozzles has yet to be explained.

Repairs to the trailing edges is somewhat routine for welders experienced with this type of specialist work. The rough edges are hand dressed, weld material is added to reconstruct the blade, and the blade profile and spacing are re-established through detailed hand dressing. Replacement of the two missing vanes was another story. This highly skilled task involved smoke, mirrors, and a good dose of magic. Nozzle box repairs were completed in the OEM's shop in less than a week.

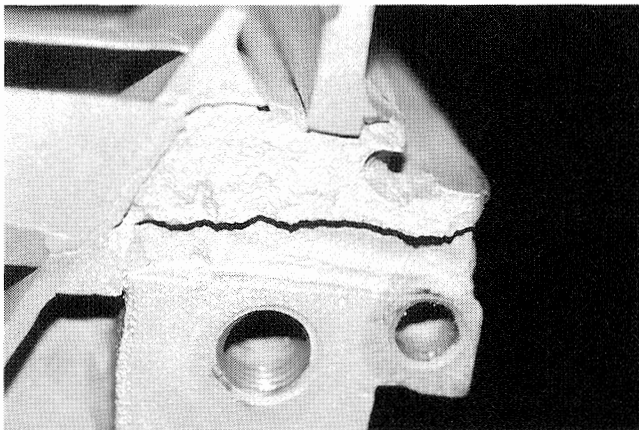
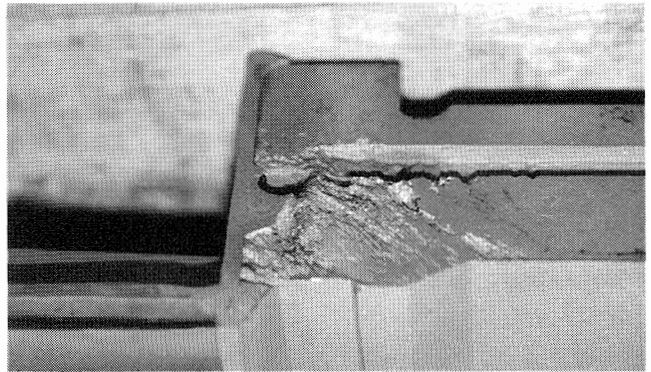
Diaphragm damage was as expected: the diaphragm splitlines and sealing surfaces of the diaphragm pockets (Figures 12, 13, 14, and 15). Most of the diaphragm alignment keys had to be repaired or replaced.

Figure 12. Diaphragm Splitline Erosion.

Figure 13. Diaphragm Splitline Erosion.

- Machine the outline (sealing area) of the splitline surface to a depth of approximately 0.125 in to prepare for welding (Figure 21). Also prepare alignment key groove for welding if necessary.
- Weld repair with Inconel material.

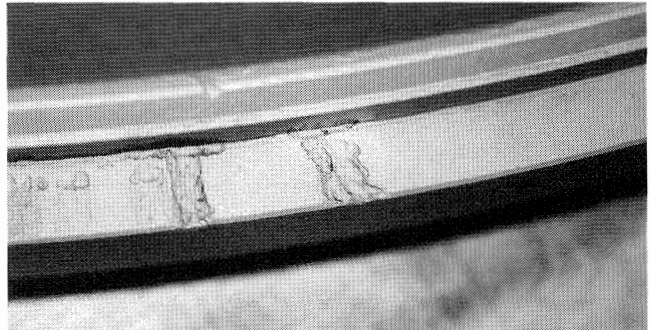
Figure 14. Diaphragm Sealing Surface Damage.

The sealing surfaces on the axial face of the OD of the diaphragm had to be repaired on stages 11 to 14B. Complete weld repair was not practical within the time available due to the possibility of warping the diaphragms. A mechanical repair method was therefore chosen (Figure 23).

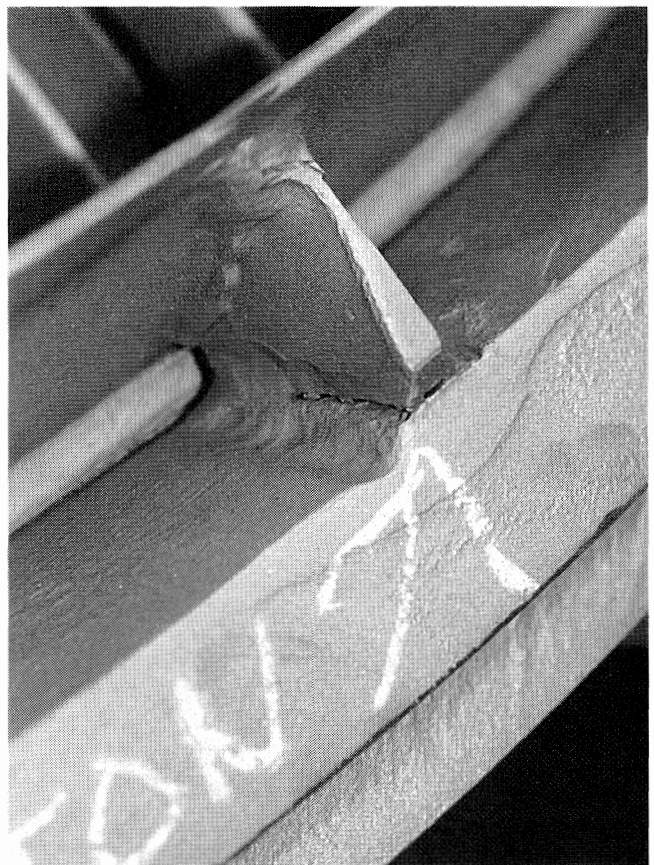
Figure 15. Weld Erosion on Twelfth Stage Diaphragm.

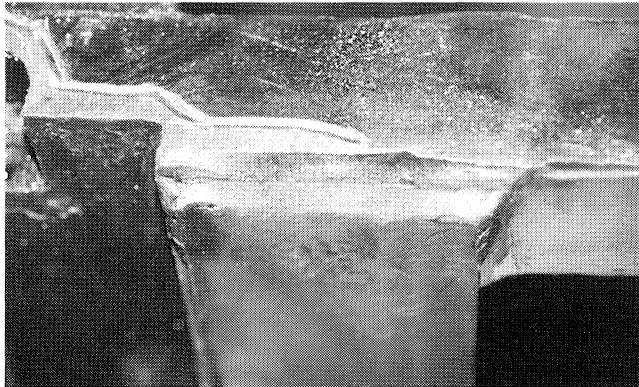
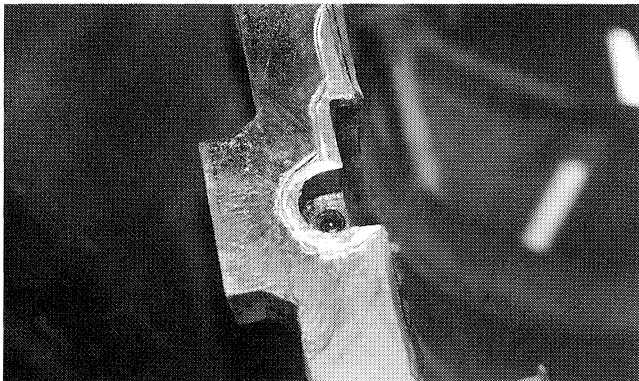
Figure 16. Casing Splitline Weld Prep.

Figure 17. Casing Splitline Weld Prep.

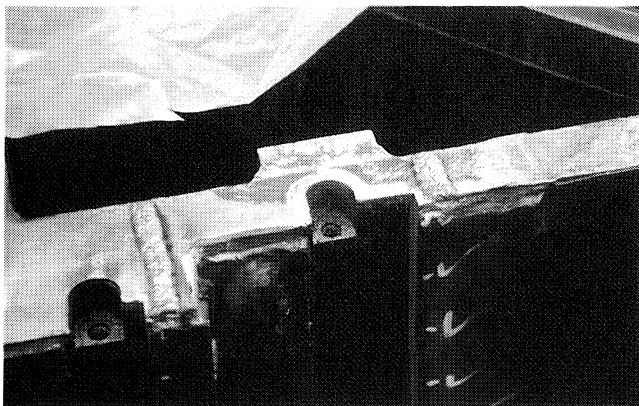
Figure 18. Casing Splitline Welding.

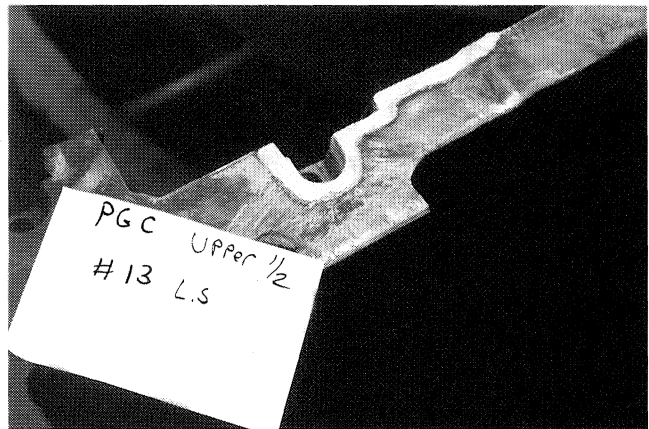
Figure 19. Typical Finished Casing Splitline Repair.

This repair technique worked very well. Splitline flatness was verified by a "blue check" of the casing halves after repairs were complete. This check showed that the objective of a flat splitline was indeed achieved.

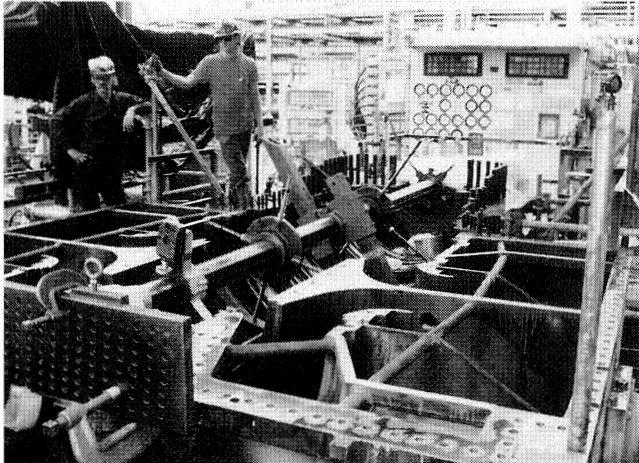
Figure 20. Boring Bar Setup.

Case boring was relatively straightforward. The boring bar was installed in the case with center reference provided by the bearing housing bore. Spider bushings supported the bar near the cutting area. After preliminary setup, the upper casing was installed and bolted down. Machinist access to the inside was provided through the valve rack flange and manways in the exhaust casing. The boring bar setup is shown in Figure 20.

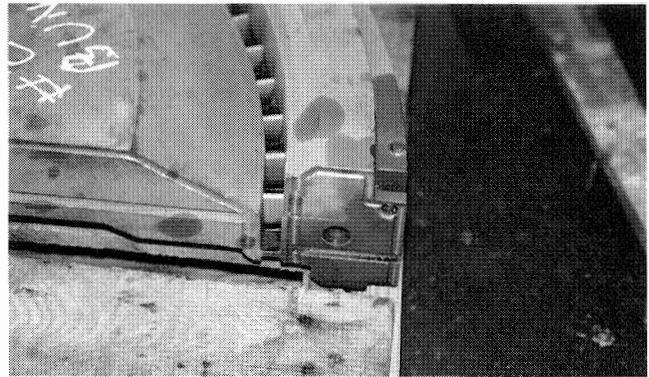
Figure 21. Diaphragm Splitline Repair Weld Prep.

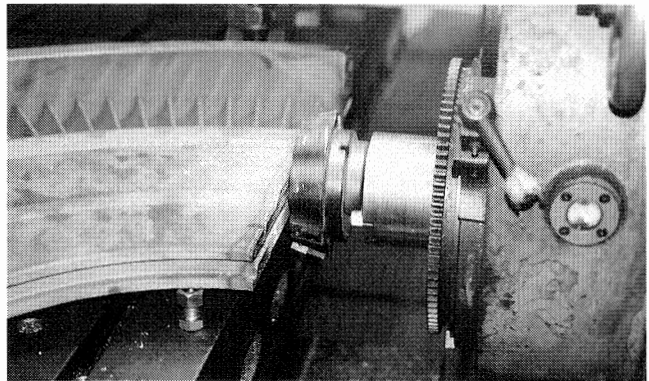
Figure 22. Machining Diaphragm Splitline.

- Machine splitline surface to establish a flat sealing surface (Figure 22). Many diaphragm leveling screw holes had washout in the threads. These were bored out, filled with weld metal, drilled and tapped to original dimensions.

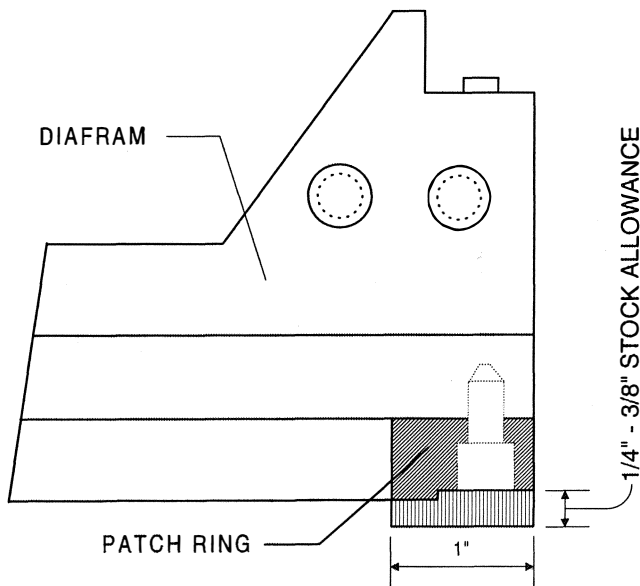
Figure 23. Diaphragm Mechanical Repair Method.

- A patch ring was made out of carbon steel plate and attached to the diaphragm by bolting. The two shops took different approaches to making the patch rings. One shop rolled the rings from barstock while the other cut the rings from plate. Both methods worked equally well and took about the same amount of time. Lesson here: don't get so stuck on one repair method that you don't consider others.

- The bolts were counter sunk and covered by weld metal. To avoid welding directly on the head of the capscrews (and thus weakening it), a washer was placed on top of the bolt head, then weld buildup on top of the washer.

- After the diaphragm grooves were field machined to final size, the diaphragm patch rings were machined to match the casing groove.
- The axial crush pins were welded up to allow for hand fitting in the field. The pins were machined 0.005 in wider than the casing groove. This made field fitting the crush pins much easier.

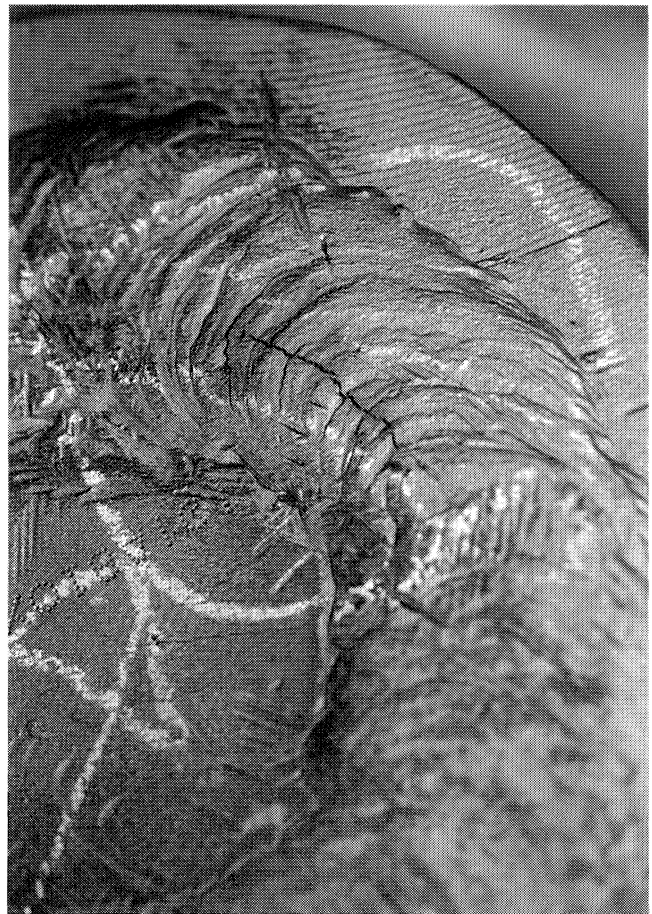
Repairs began with a thorough blast cleaning of the nozzle box casing. Machined areas and the nozzles were masked off to prevent damage. These areas were hand cleaned. NDT examination of the case revealed several cracks (Figure 24) on the side opposite the nozzle ring. These cracks were located in and around welds made to seal up coring plugs. Excavations of these cracks indicated they went all the way into the interior. The cracks were excavated until removed and then carefully weld repaired. Due to numerous machined surfaces on the nozzle box, it was highly desirable to weld repair in such a way that post weld heat treatment was not required. This was accomplished through careful selection of filler material and weld techniques.

Figure 24. Crack in Nozzle Box.

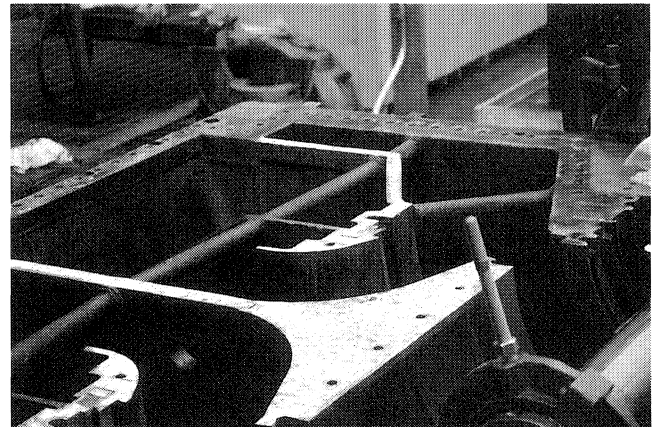
The inner exhaust casing was open at the splitline. This casing has no bolts holding it together and has apparently opened up from thermal stresses. The inner casing separates the double flow stages from the condenser inlet.

The blue check of the splitline and visual observations revealed a significant gap in the splitline at the stage 14A/14B flow splitter (Figure 25). There was no contact and, in fact, a 1/16 in to 1/8 in gap was visible. Unfortunately, this gap was not discovered until about half of the available maintenance time was used. With not enough time left in the outage to do anything about it, the decision was made to leave it as is. It can be seen from Figure 25 that there was no erosion damage in this area. This area of the turbines will be considered for installation of some internal bolting at the next outage.

Figure 25. Blue Check of Splitline.
